Statewide California Earthquake Center
Final Technical Report
Project 22104

Landers Earthquake scarp after 30 years

Technical Report Narrative

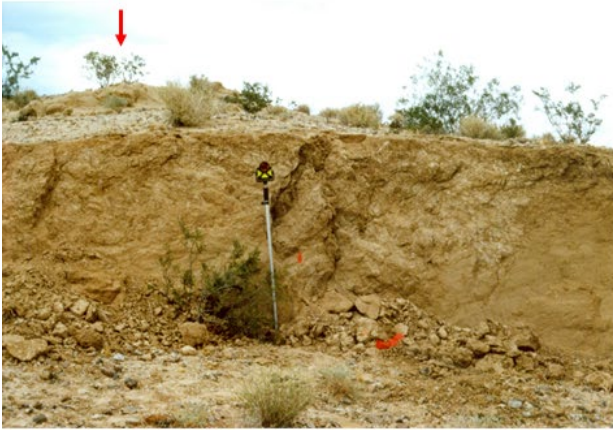
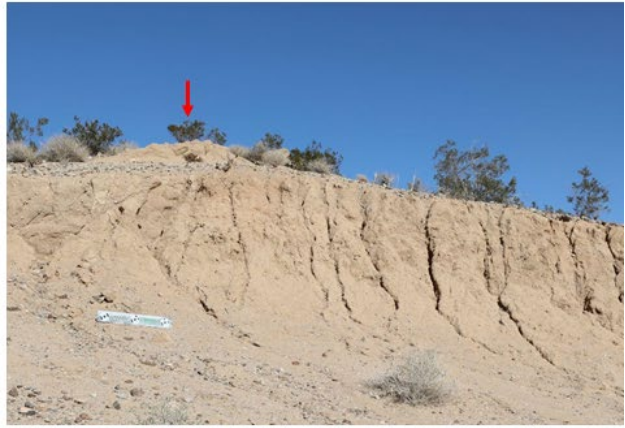
Figure 2. Scarp 1 changes over 30 years. See figure 1 for location.

Scarp 1 Changes in 30 Years

- 1) The edge of the scarp has softened.
- 2) The face of the scarp is gullied.
- 3) Erosional debris has accumulated at the base of the scarp.

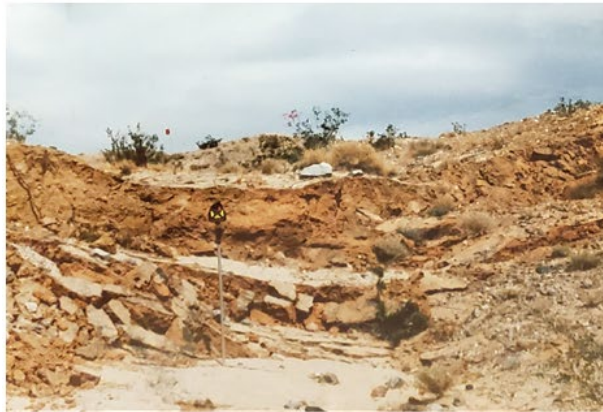
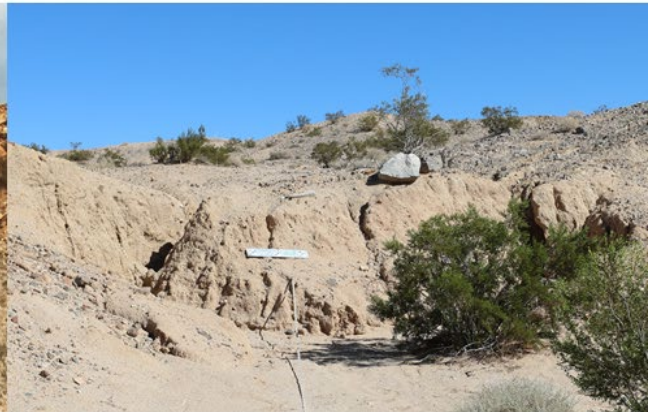
Figure 3. Gully 3 changes over 30 years. See figure 1 for location. Note grey rock for reference.

Gully 3 Changes in 30 Years

- 1) Incision and retreat of narrow knick channels
- 2) Scarp smoothing and loss of complex structure from rupture

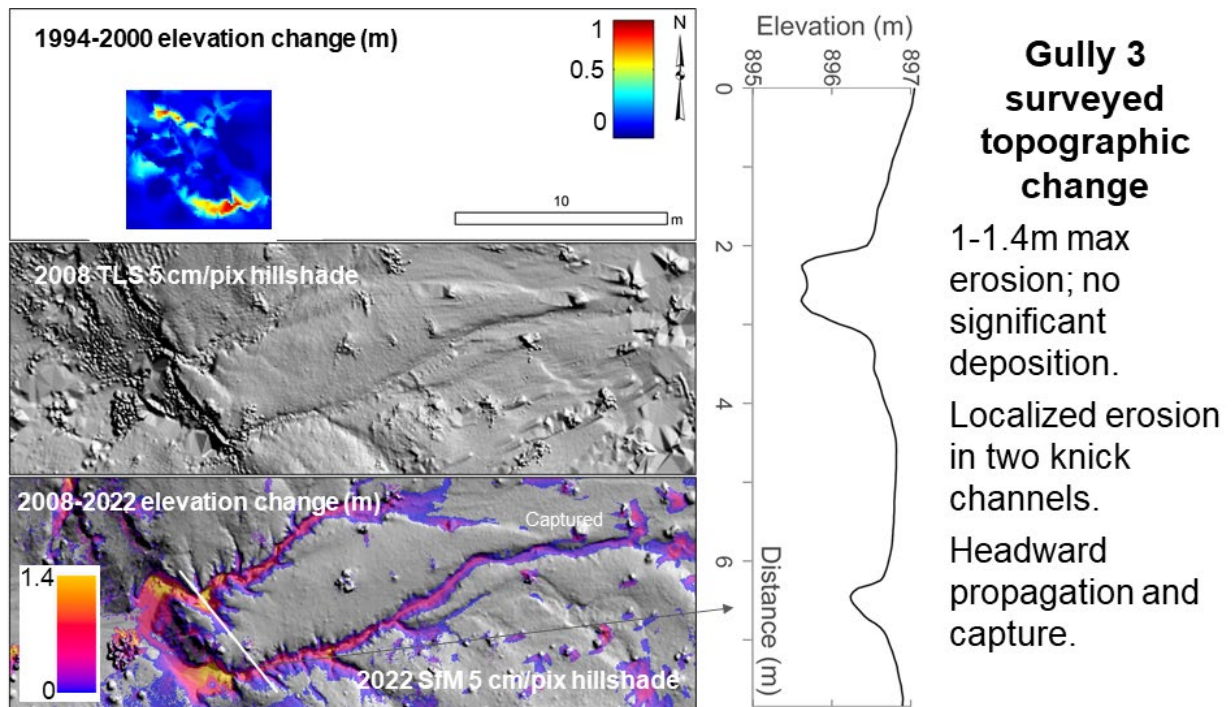
Figure 4. Gully 3 surveyed topographic change. The three maps (left column) have the same extent. The upper panel shows the 1994-2000 elevation change. The lower panel shows the change from 2008 to 2022 and illustrates the headward growth of the erosion signal. 1-1.4 m of maximum erosion is observed with no significant deposition.
