Statewide California Earthquake Center
Final Technical Report
Project 22104

Landers Earthquake scarp after 30 years

Technical Report Narrative

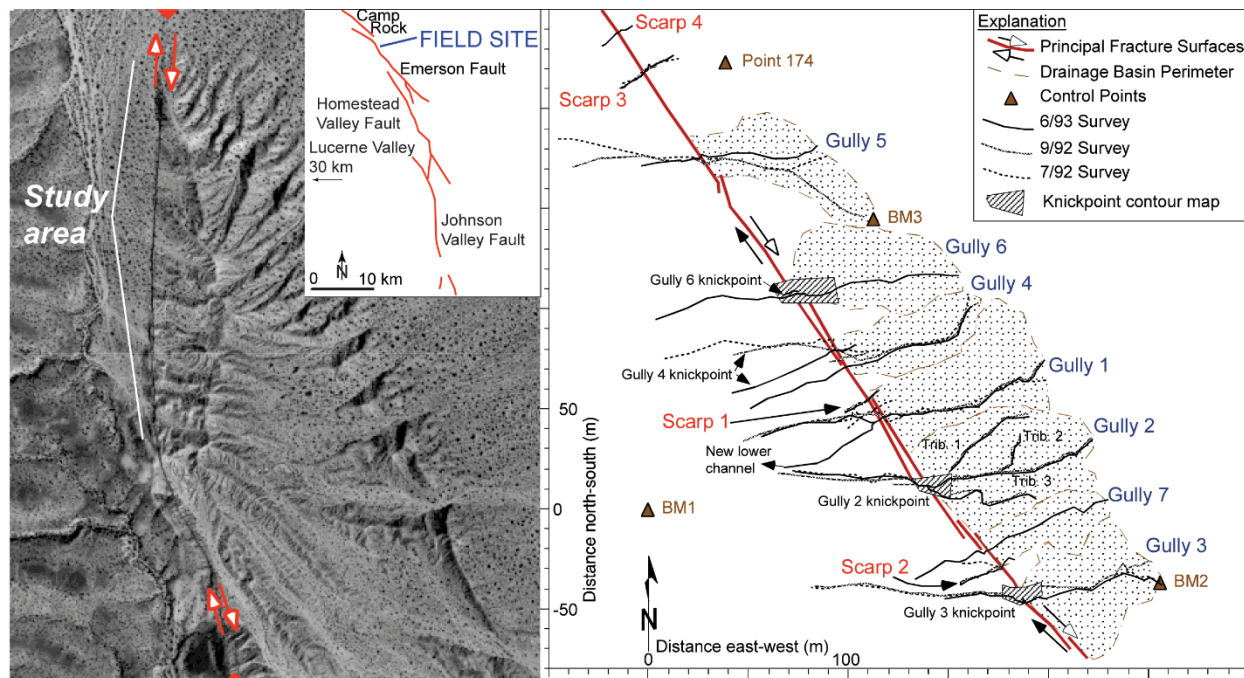
Figure 1. Field site along the northern Emerson fault which ruptured in the M7.3 1992 Landers earthquake. Left image inset shows the study area location along the rupture zone (red lines). Aerial photograph taken by USGS immediately after the earthquake shows surface rupture trace along uplifting folded basin and alluvial fan sedimentary units and the study area. White rectangles indicate Figure 3 panel locations. At right, the map illustrates the main landforms whose investigations and monitoring began immediately after the earthquake.
